## AN EVALUATION ON THE HYDROGEOMORPHOLOGICAL PROPERTIES OF THE EŞEN STREAM BASIN<sup>1</sup>

**Recep BOZYIGIT**

The purpose of the study “An Evaluation On The Hydrogeomorphological Properties Of The Eşen Stream Basin”, is to reveal the problems which have formed problems or having the risk of problem formation depending on the geomorphological and hydrological properties the basin has. The Eşen Stream Basin, is situated within the Muğla-Antalya provincial borders of Mediterranean Region, Antalya Section. The basin is divided into two large geomorphological units with young tectonic movements starting from Miocene-Pliocene and continuing along the Quaternary. One of which is the Seki Basin that is covered with vast mountainous and platelike lands broken a little with tectonic effects in the north-east; the other is the Lower Eşen Stream Basin, which is torn by N-S and NW-SE direction faultline in the south. The erosion-accumulation activities, geological structure, tectonism, high slope values of the Eşen Stream and the auxiliary branches, which have not yet reached a balance profile in winning today's relief, have been influenced by the values of the Eşen Stream Basin. Soil eros

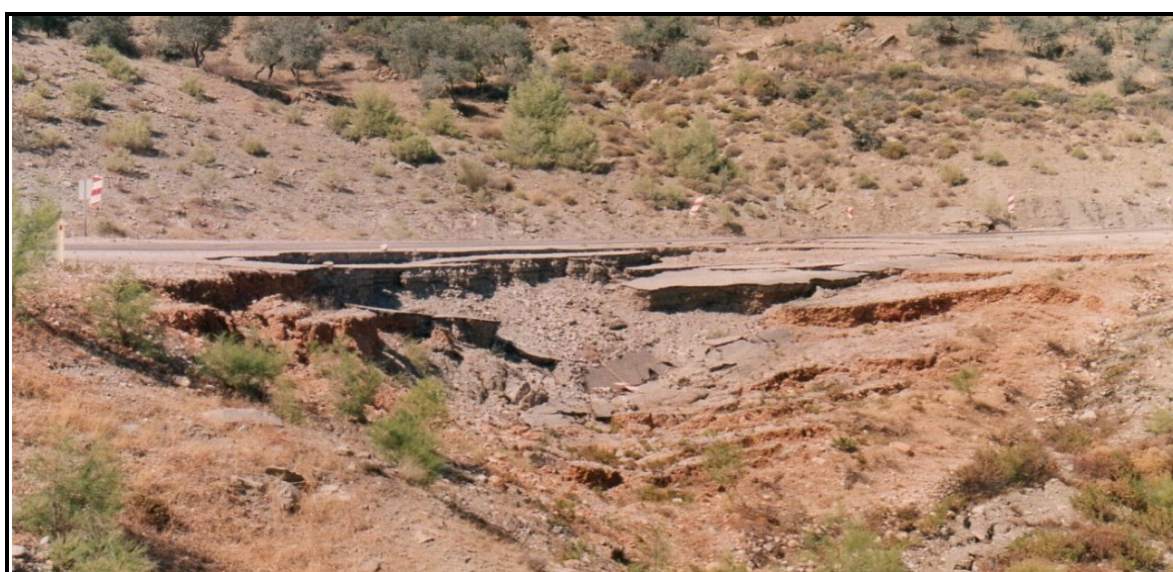
**Photograph 2.** Damaged Highway of the Landsliding Region in Kemer-Antalya Highway's 5.th Kilometer

**2.2. Landslides:** The landsliding fields within the Eşen Stream Basin are common in the sections where the slope is more when passed from the high mountainous fields to the plain and valley bottoms. They are not very common. Because the factors causing the landslide are present at particular points of the basin. As a result, a large proportion of the landslides which occurred until today, has been determined to have formed in the fields made for place gaining from the forest and in the road cuts. The flysch series situated on the mesozoic limestones of the road cut in the 8. kilometer of the Kemer-Ceylan road, have been observed to slide to the west from time to time. Also the Eocene flysch series deformed in terms of balance in the 5 and 10. kilometers of the highway between Kemer and Antalya, slide through the Kincılar Stream from the main rock and hinder the highway traffic from time to time (Photograph 2-3). In a field section in the Kirsecik quarter of Bayırköy at the 12. Kilometer of the Kemer-Antalya highway, no life has been lost during the landslide of 1978-1979 winter, some houses have been damaged.

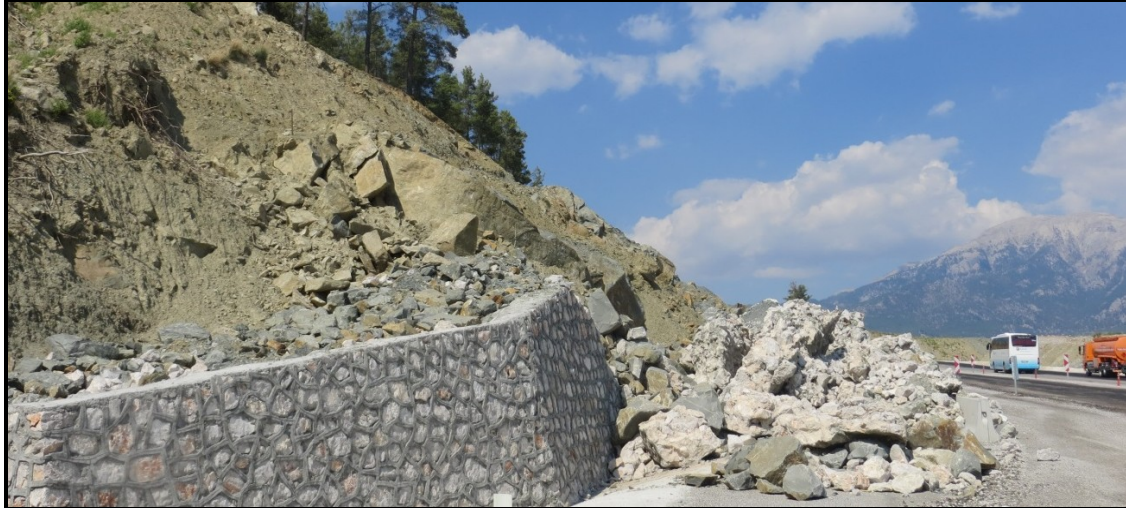
**Photograph 3.** The Landslide Forming at the 10.th Kilometer of Kemer-Antalya Highway from Time to Time Hinders the Highway Traffic.

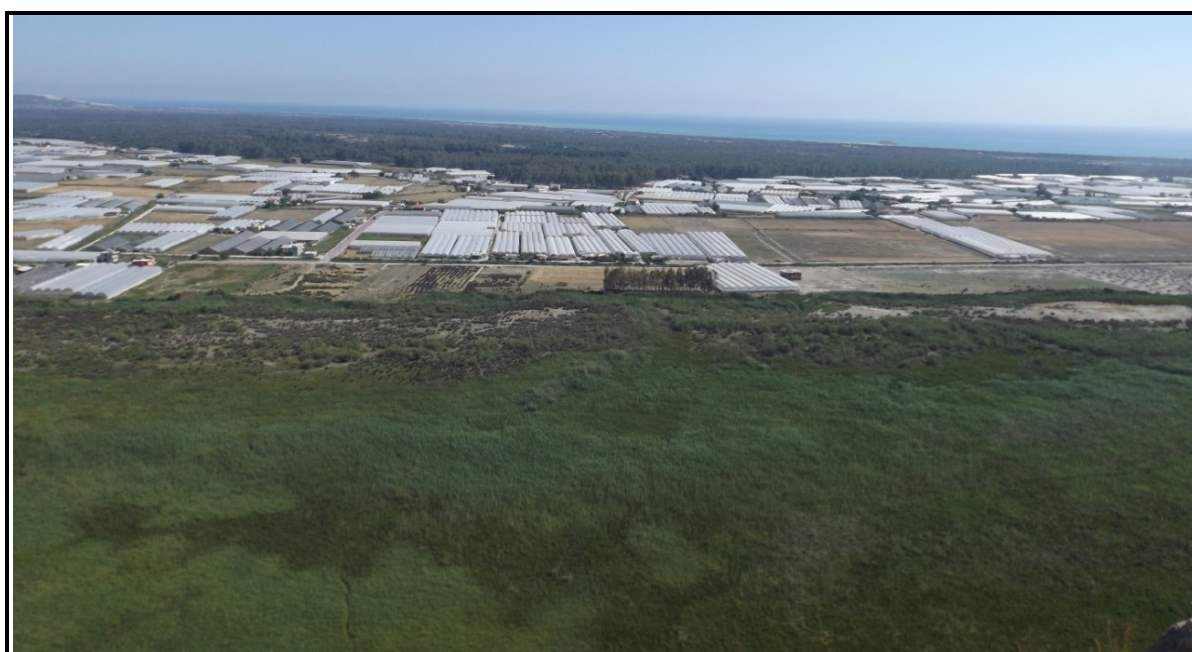
**Photograph 6.** Marsh Fields on the Ada Position of Delta in the Eşen Stream

*2.3.6.Delta Plain:* Eşen Stream, enters into the delta plain after the Kınık Pass and flows in the north south direction showing a braided draining. The stream that is included in a meandering bed near Kerimler district later on, reaches the sea from Çayağzı district. In order to prevent damages during floods, floodgates were made on both sides of Eşen Stream until the Kerimler quarter of town of Kınık, in the south of Kumluova. Despite these floodgates which have partially prevented from floods, the water spreads from the stream bed, which is flattened in floods, and formed a 20-25 km<sup>2</sup> flowage plain. In areas where the groundwater level is very close to the surface, after floodwaters the swamps and ponds have formed. In particular, there are marshes which are caused by floods in the vicinity of Kerim and Ada (Photograph 6).

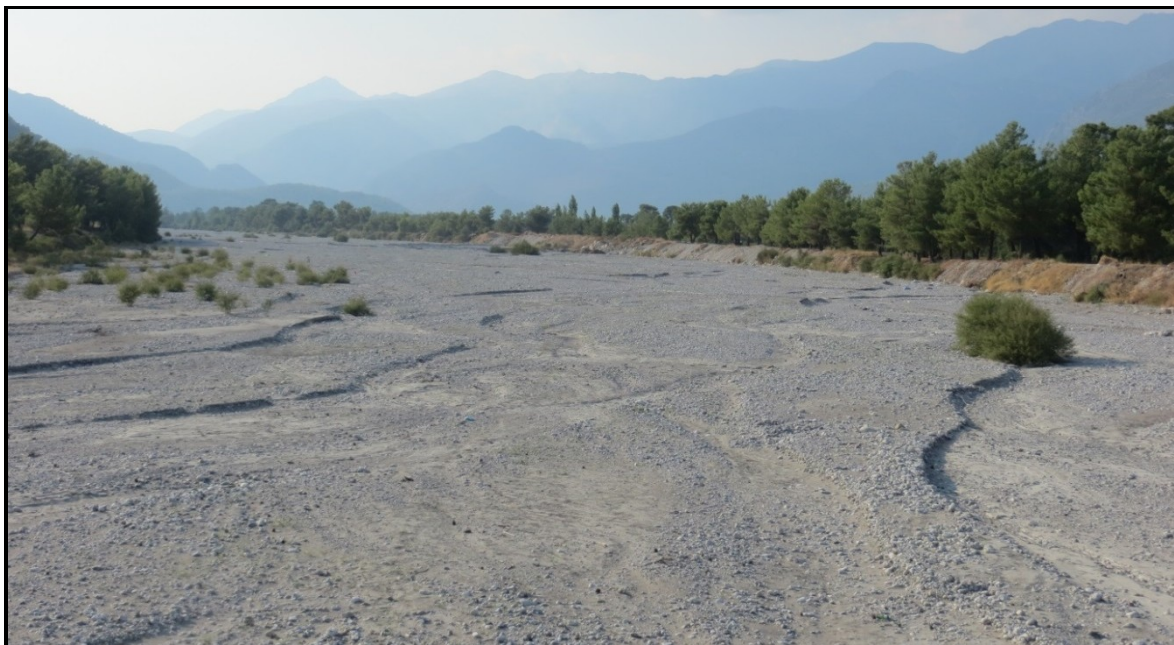
**Photograph 7.** View of Akçay (Deliçay) Stream Bed Having Lost Its Water in Summer Season

**2.4. Slantings:** In the field of examination, in the period between November and March the streams are relatively high as a result of the more frequent heavy rains, when the rain is seen more, they become thinner during the hot and dry summer. There is no water in Akçay (Photograph 7) and in Tezli Stream in summer except for the Eşen Stream, Seki Stream and Karaçay. The lowest flow values are seen in August in the Eşen Stream and Seki Stream. The long during average flow in the Eşen Stream in that month has been 22.7 m<sup>3</sup>/seconds. The period where the thin version of the main streams having the constant flow in the examination field starts from the June month's beginning until the end of November, corresponds to an arid period (Table 2).

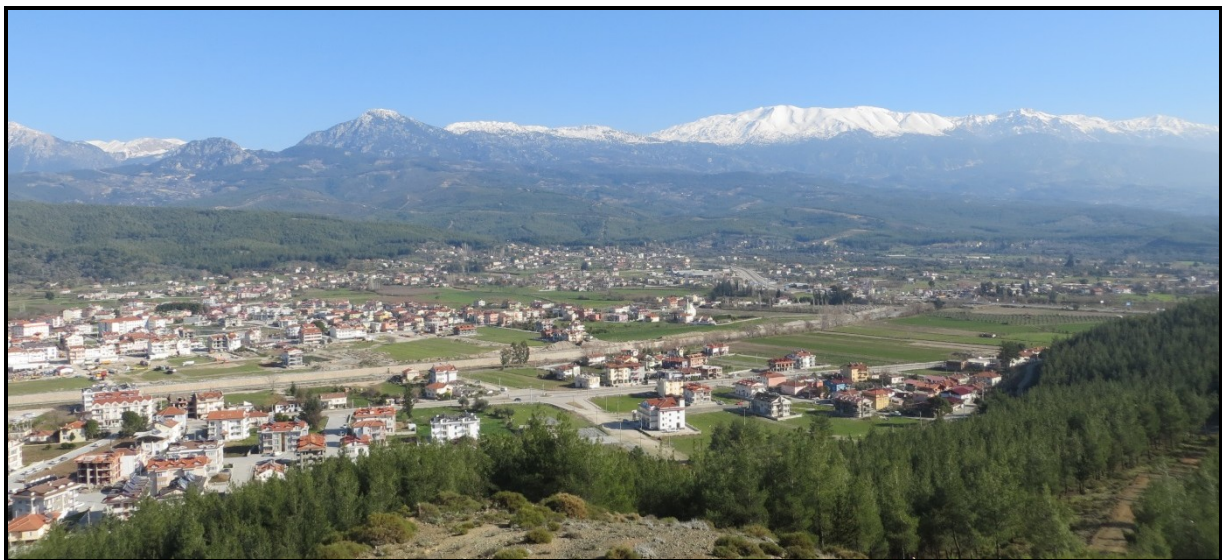
**Photograph 8.** The Eşen Stream Graben which is Extending in the North-South Direction.

The presence of trenches and young faults in the basin and the presence of some ancient cities under water and alluvium show the influence of young tectonic movements. The N-S, NE-SW direction (Photograph 8) on the Eşen Stream Graben extending in the north-south direction produced a large number of sloping normal faults (Map 3).

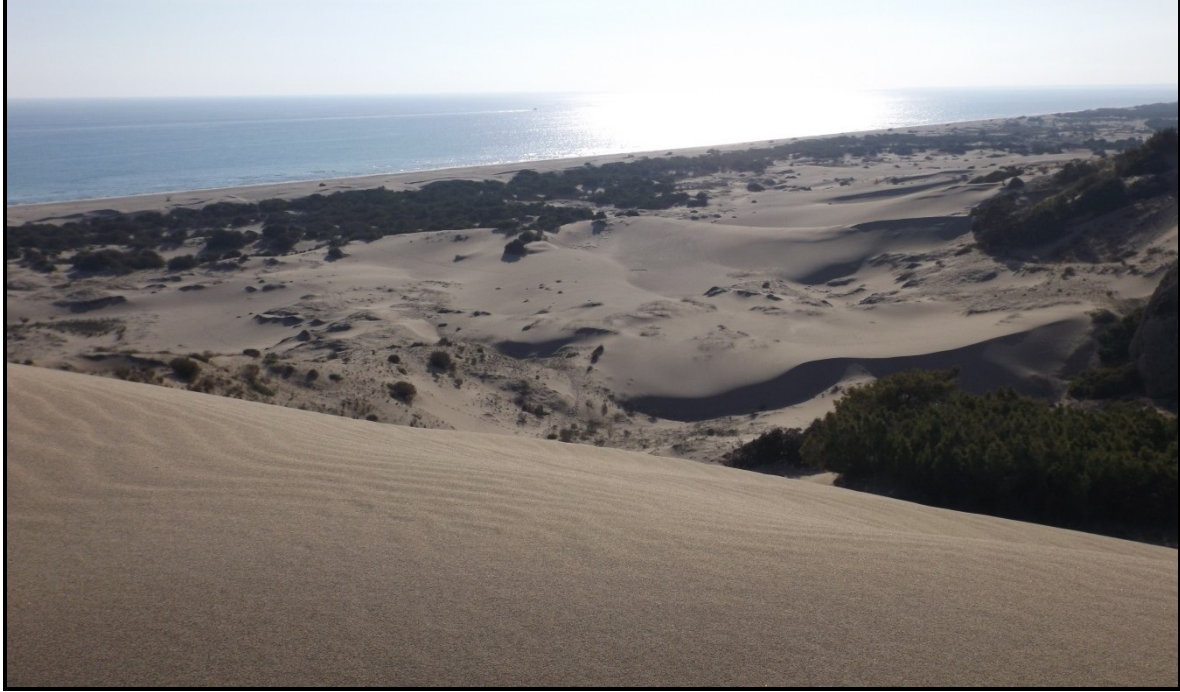
**Photograph 9.** Coastal Dunes in the Eşen Stream Delta Plain

**2.6. Moving Dunes:** There are sand dunes along the coast of the Eşen Stream Delta Plain, which is located in the study area (Photograph 9). It lies 12 km from the Zeytin Cape in the west to İnceburun in the east. The moving sand dunes are 4 km within the west of the delta area (Map 3).

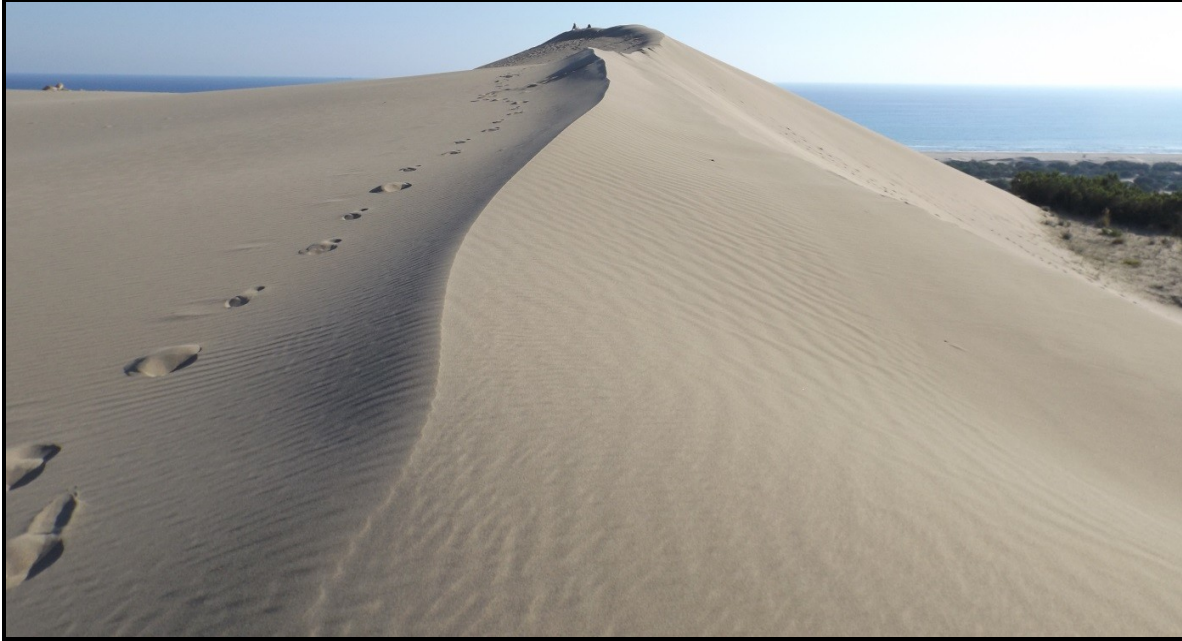
**Photograph 10.** An Appearance of the Dune Hills in the Eşen Stream Delta

The sand, silt and clay sized material brought to the sea by the Eşen Stream, which is the source of the sand that forms the sand dune field was formed as a result of the accumulation by the waves and scattered on both sides of the delta front (Photograph 10). From time to time, the lagoons and set lakes have formed as a result of the shifting of the moving dunes and lagoon. Efforts to prevent sand dune erosion, initiated by the Ministry of Forestry in 1961, have yielded successful results. The fact that the coastal dunes take off by the influence of the southern sector winds and reach up to the hills 5 km inside the coast, the part of the ancient city of Patara covered with coastal sand dunes and the removal of them from the sea by sand dunes are evidences showing what the effects of sand dunes might be. The cutting of the eucalyptus forest by the neighborhood people, today which was formed as a result of the afforestation activities may cause the sand dunes to move again. Measures must be taken for preventing that.

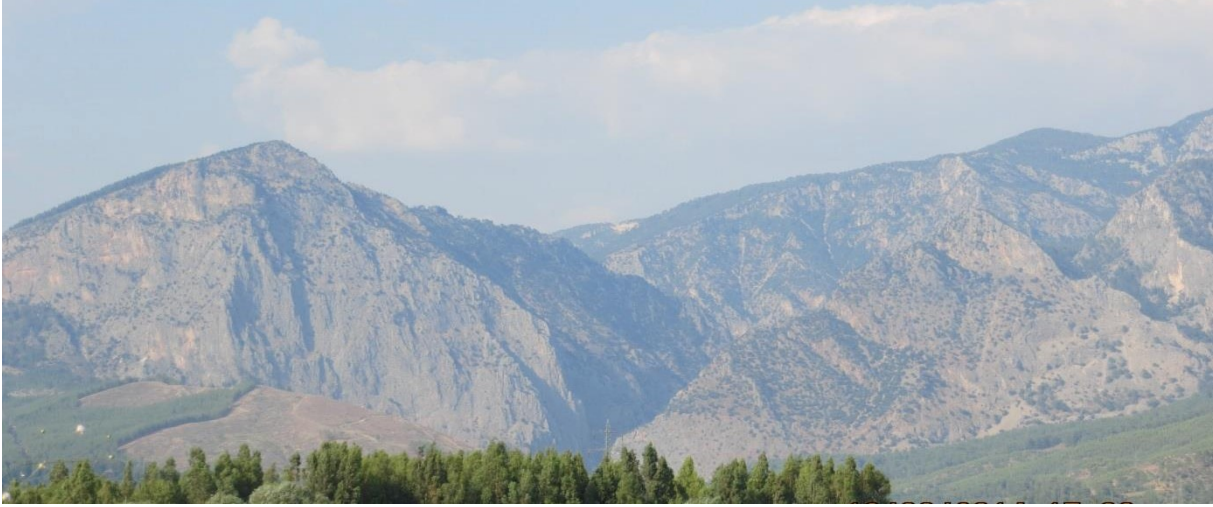
**Fotoğraf 1.** Ören Fayı; Güneydağı'nın(1046 m) Güney Kenarında Yüzeyleyen Fay NW-SE Doğrultulu Eğim Atımlı Normal Faydır.

Havza, aynı zamanda faylarla da parçalanmış bulunmaktadır(Fotoğraf 1). Genel doğrultuları kuzey-güney olan ana fayların yanında tali faylar da yer almaktadır. Basamaklı bir özellik gösteren bu faylar, Eşen Çayı Vadisi'nin bir grabene tekabül ettiği fikrini kuvvetlendirmektedir. Vadi tabanında, özellikle yatağın genişlediği sahalarda örgülü mecra görülmektedir. Ancak fay hattına cephe sahalarda iki büyük kanyon vadi meydana gelmiştir.

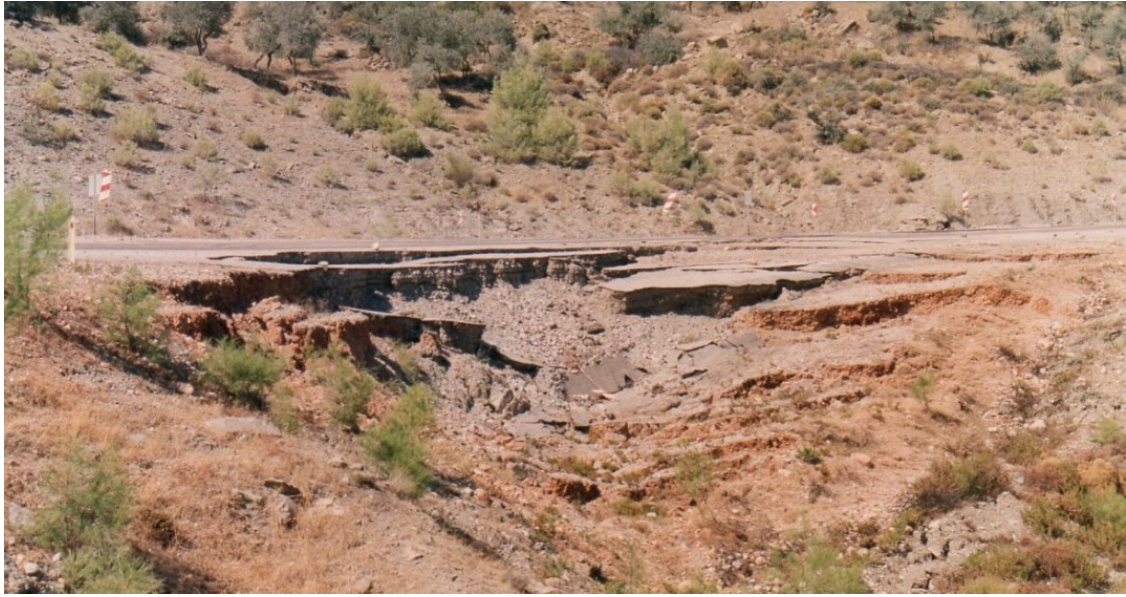
**Fotoğraf 2.** Kemer-Antalya Karayolunun 5. Kilometresindeki Heyelanlı Bölgede Tahrip Olmuş Karayolu

**2.2. Heyelanlar:** Eşen Çayı Havzası'nda heyelanlı sahalara, yüksek dağlık sahalardan ova ve vadi tabanlarına geçildiğinde eğimin fazla olduğu kesimlerde rastlanmaktadır. Bunlar pek yaygın değildir. Çünkü heyelanlara sebep olan faktörler havzanın muayyen yerlerinde bulunmaktadır. Nitekim bugüne kadar vuku bulmuş heyelanların büyük bir kısmı ormandan yer kazanmak üzere açılmış sahalara ile yol yarmalarında meydana geldiği tespit edilmiştir. Kemer-Ceylan yolunun 8. kilometresindeki yol yarmasında Mesozoik kalkerler üzerinde yer alan flišli serinin yer yer batıya doğru kaydığı gözlenmiştir. Ayrıca Kemer'i Antalya'ya bağlayan karayolunun 5 ve 10. kilometrelerinde denge açısı bozulan Eosen fliš serileri ana kayadan doğudaki Kıncılar Deresi'ne doğru kaymakta ve zaman zaman karayolu trafiğini aksatmaktadır(Fotoğraf 2-3). Kemer-Antalya karayolunun 12. kilometresindeki Bayırköy'e bağlı Kirsecik mahallesindeki bir bölüm arazide, 1978-79 kışında meydana gelen heyelânda can kaybı olmamakla beraber, bazı evlerin hasar gördüğü tespit edilmiştir.

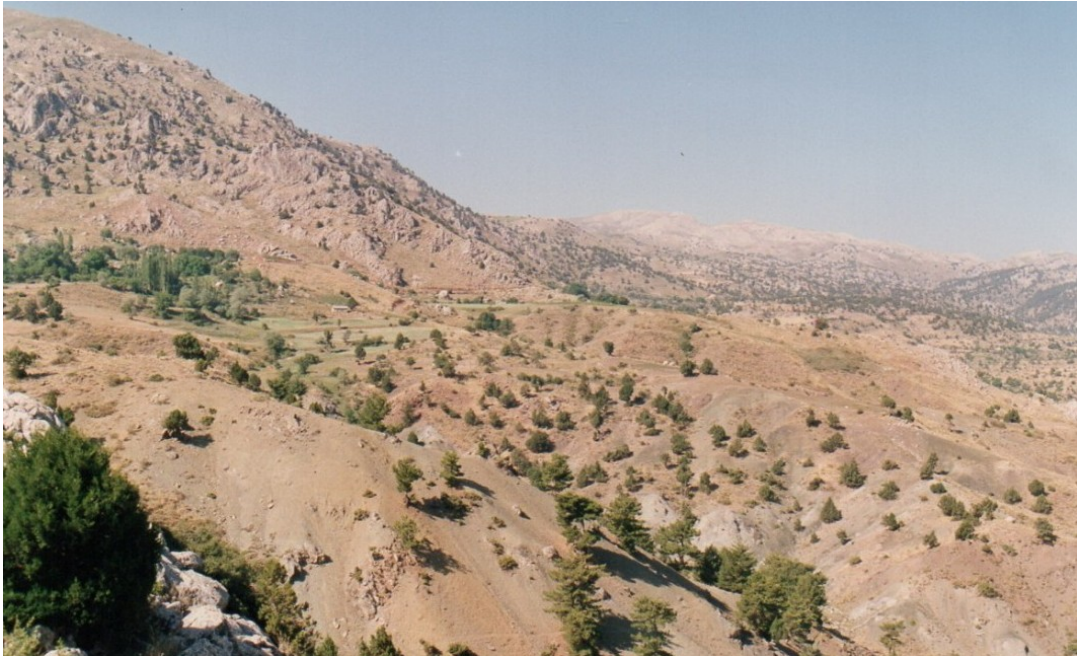
**Fotoğraf 4.** Eren Tepe'nin (2677 m) Kuzey Yamaçları Heyelan Tehdidi Altında Bulunmaktadır.

Seki Havzası'nın güneyinde birdenbire yükselen Eren T. nin (2677 m) kuzey yamaçları kademeli faylarla parçalanmıştır. Altta ofiolitler, üstte ise diskordant olarak kalker tabakaların yer aldığı sahada; Temelköy, Ceylanköy her an heyelana maruz kalacak topoğrafyadadır (Harita 2). Arazide heyelânın halen devam ettiğini gösteren delillere rastlanmaktadır(Fotoğraf 4).

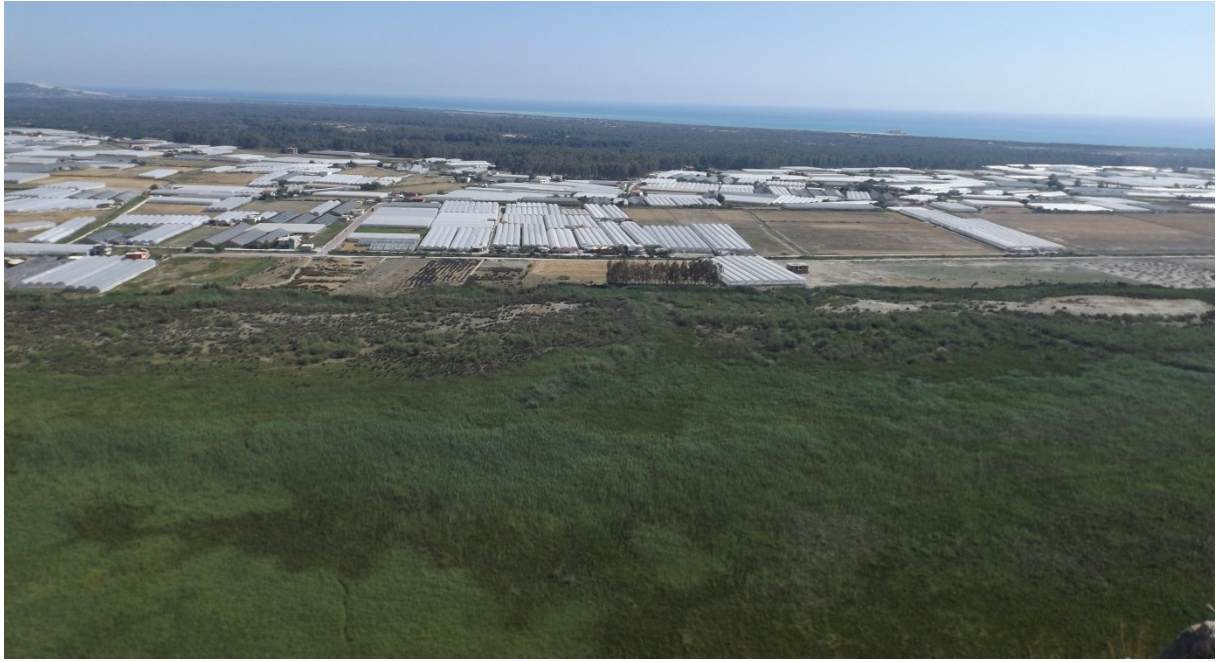
**Fotoğraf 6.** Eşen Çayı Deltasındaki Ada Mevkiindeki Bataklık Sahalar

**2.3.6.Delta Ovası:** Eşen Çayı, Kınık Boğazı'ndan sonra delta ovasına girmekte ve örgülü drenaj özelliği göstererek kuzeyden güneye doğru akmaktadır. Daha sonra Kerimler mahallesi yakınlarında menderesli bir yatağa dahil olan akarsu, Çayağzı mevkiinden denize ulaşmaktadır. Taşkın esnasındaki zararları önlemek amacıyla Kınık kasabası ile Kumluova güneyindeki Kerimler mahallesine kadar Eşen Çayı'nın her iki kenarında seddeler yapılmıştır. Kısmen taşkınların önlendiği bu seddelere rağmen, taşkınlar basık şekilde olan akarsu yatağından sular çevreye yayılmakta ve 20-25 km<sup>2</sup> lik bir feyezan ovası teşekkül ettirmiştir. Yeraltı su seviyesinin oldukça yüzeye yakın olduğu kesimlerde taşkınla müteakip bataklık ve göllenme meydana gelmektedir. Özellikle Kerimler ve Ada mevkilerinde taşkınların yol açtığı bataklıklar görülmektedir (Fotoğraf 6).

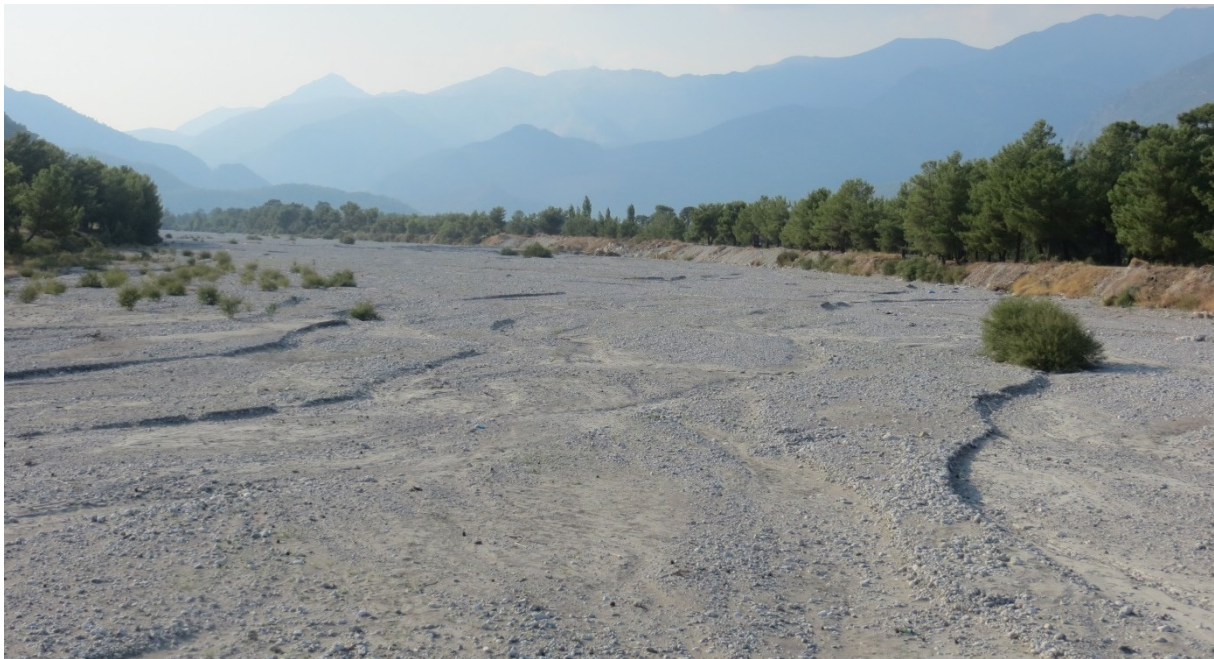
**Fotoğraf 7.** Yaz Mevsiminde Sularını Kaybeden Akçay(Deliçay) Dere Yatağından Görünüm

**2.4. Çekikler:** İnceleme sahasında, yağışların nispeten yüksek olduğu ve sağanak yağışlarında fazla görüldüğü Kasım-Mart arasındaki devrede taşkınlara sebep olan akarsular, sıcak ve kurak geçen yaz mevsiminde cıızlaşırlar. Eşen Çayı, Seki Çayı ve Karaçay dışındaki Akçay (Fotoğraf 7) ve Tezli Deresi'nde yaz aylarında su bulunmaz. Eşen Çayı ve Seki Çayı'nda en düşük akım değerlerine Ağustos ayında rastlanır. Eşen Çayı'nın bu aydaki uzun süreli ortalama akımı  $22.71 \text{ m}^3/\text{sn}$ 'dir. İnceleme sahasının sürekli akışa sahip ana akarsularında çekik halinin görüldüğü devre Haziran ayı başlarından Kasım ayı sonuna kadar olup, kurak bir döneme tekabül etmektedir.

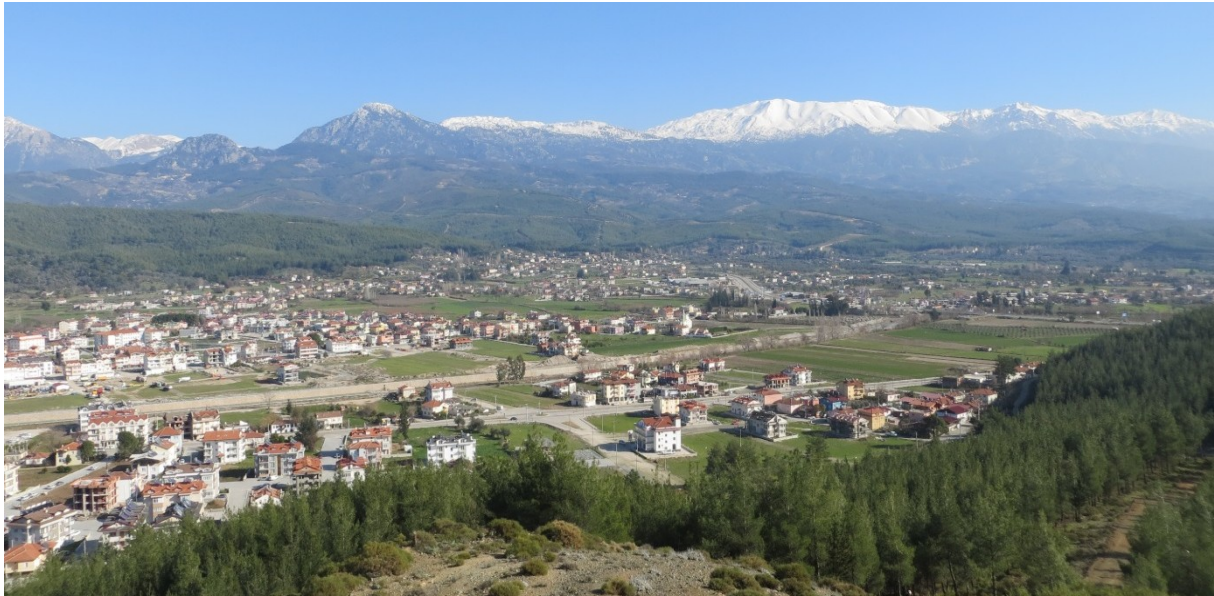
**Fotoğraf 8.** Kuzey-Güney Yönünde Uzanan Eşen Çayı Grabeni.

Havzada, basamaklı ve genç faylar ile bazı antik kentlerin su ve alüvyonlar altında bulunması genç tektonik hareketlerin etkisini göstermektedir. Kuzey-güney istikametinde uzanan Eşen Çayı Grabeni üzerinde N-S, NE-SW doğrultulu (Fotoğraf 8) çok sayıda eğim atımlı normal fay teşekkül etmiştir(Harita 2).

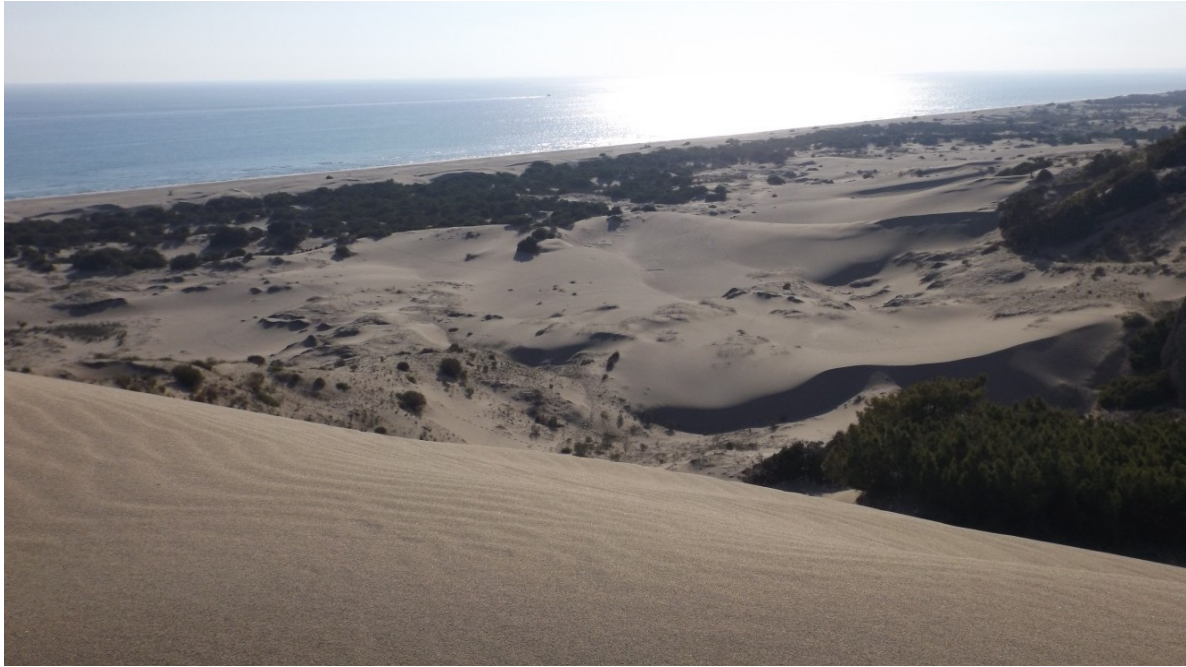
**Fotoğraf 9.** Eşen Çayı Delta Ovası’ndaki Kıyı Kumulları

**2.6. Hareketli Kumullar:** Etüt sahasında yer alan Eşen Çayı Delta Ovası’nın kıyısı boyunca kumullar yer alır (Fotoğraf 9). Batıda Zeytin Burnu’ndan, doğudaki İnceburun’a kadar uzanan 12 km’lik mesafede bulunur. Hareketli kumullar, delta sahasının batı yakasında 4 km. kadar içeriye sokulmuşlardır (Harita 2).

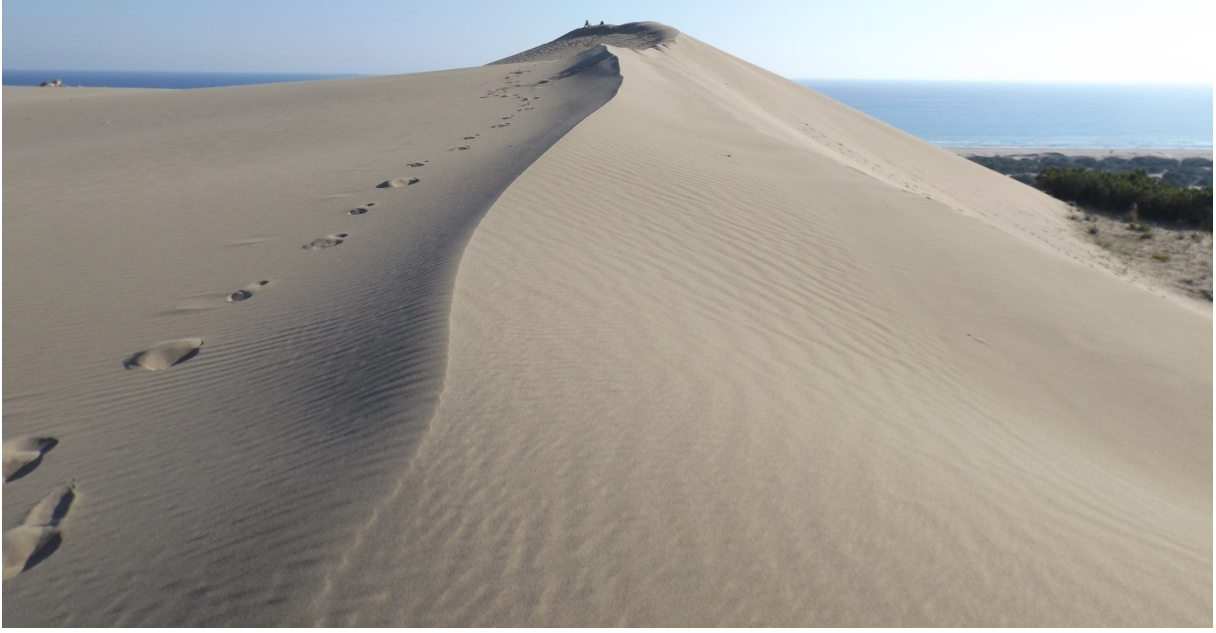
**Fotoğraf 10.** Eşen Çayı Deltası'ndaki Kumul Tepelerinden Görünüm

Kumul sahasını meydana getiren kumların kaynağı Eşen Çayı'nın getirdiği kum, silt ve kil boyutundaki malzemenin denize bırakılması, daha sonrada dalgalarla da delta cephesinin her iki tarafına doğru dağıtılarak biriktirilmesi sonucunda teşekkül etmiştir(Fotoğraf 10). Zaman zaman hareketli olan kumulların yer değiştirmesi ile oluşmuş lagon ve set gölcükleri meydana gelmiştir. Orman Bakanlığı tarafından 1961 yılında başlayan kumul erozyonunu önleme çalışmaları başarılı sonuçlar vermiştir. Kıyı kumullarının güney sektörlü rüzgârların etkisiyle havalanarak kıyıda 5 km içerdeki tepelere kadar ulaşması, Patara antik kentinin kıyı kumullarıyla kısmen örtülerek buradaki koyun kumullarla denizden koparılması, kumulların etkilerinin neler olabileceğini gösteren delillerdir. Bugün ağaçlandırma çalışmaları sonucunda teşekkül etmiş okalıptüs ormanının çevre halkı tarafından kesilmesi, kumulları tekrar harekete geçirebilir. Bunun için gerekli önlemlerin alınması gerekmektedir.
