# Quality and leakage of perforation repair-materials: A comparison of intracoronaral and retrograde techniques

*Selcuk Dental Journal*, 2014; 3: 92-100

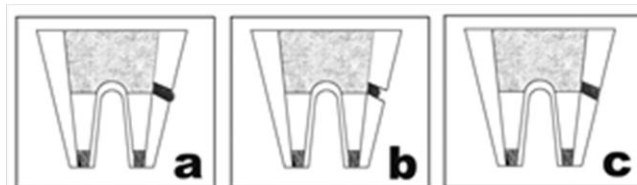
**Figure 1.**

Schematic representation of the scoring the restorations as:  
a: extruded; b: insufficient and c: adequate

Intentional perforations were created at the mesial and distal root surfaces (below the CEJ) by using a slow-speed round bur (#2) at approximately a 45-degree angle to the long axis of each tooth under water coolant (Figure 1). This technique created a 1-mm diameter perforation site, and the dentin thickness was standardized at 1.6 mm by grinding from the internal surface of the access cavity with a diamond bur. Perforations were thoroughly irrigated with saline solution to avoid any remnants of visible debris. The prepared teeth were then inserted into a saline-soaked Oasis, a material widely used for flower arrangements, to approximate the level of the CEJ (Lee et al 1993). This set-up provided a model

All of the access cavities were sealed with IRM and distal perforations were repaired externally by removing the oasis material to provide visibility. The perforations in six teeth (Group 6) were not repaired and served as positive controls; six non-perforated teeth were used as negative controls (Group 7). The teeth were stored at a temperature of 37°C and 100% humidity conditions for 24 hrs. With the exception of 1 to 2 mm around the perforation sites, the root surfaces were covered with a double layer of nail polish. The samples were then placed in 2% methylene blue for 24h, washed with tap water and separated into two bucco-lingual sections that were parallel to the long axes of the teeth. The separation occurred down the center of the perforations to expose the filled perforated site by using a low-speed handpiece. The sections were evaluated under stereomicroscope (X20-X40, Olympus SZ40, Japan). The extruded (Figure 1a), insufficient (Figure 1b) and adequate (Figure 1c) restorations were recorded and scored in combination with the dye penetration as follows:

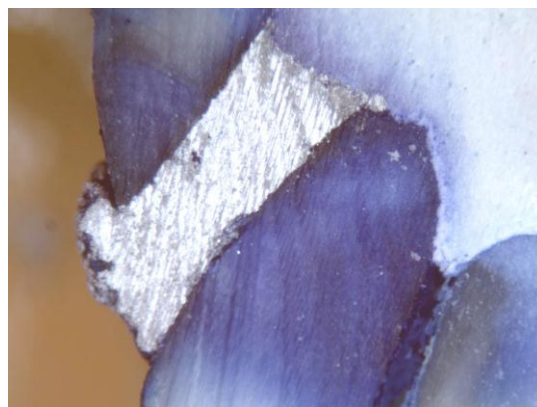
**Figure 2.**

Total leakage with an amalgam restoration placed orthogradely considered as score 1

**1)** Extruded restoration with leakage toward the restoration-root interface (Figure 2);

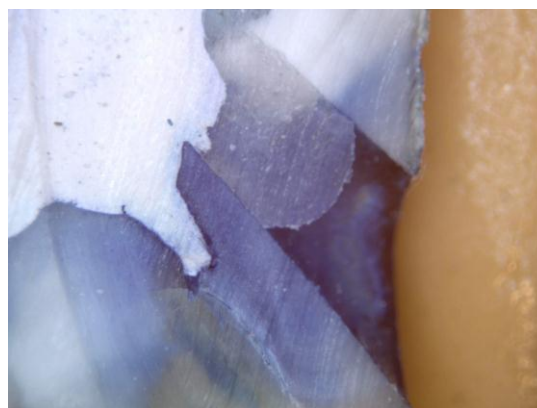
**Figure 3.**

Total leakage with an insufficient Super Bond C&B restoration placed orthogradely considered as Score 2

**2)** Insufficient restoration with leakage toward the restoration-root interface (Figure 3);

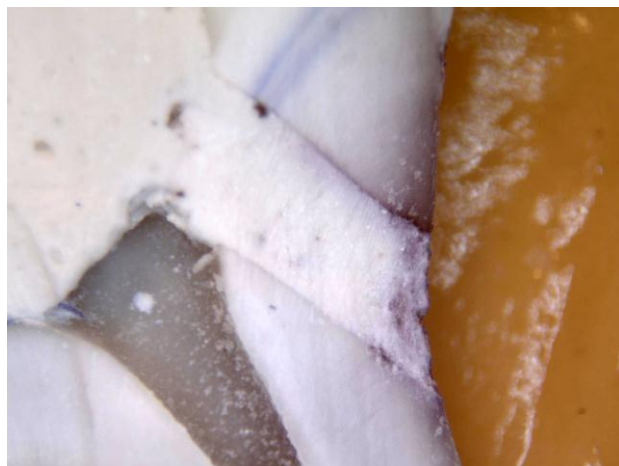
**Figure 6.**

Partial leakage with an adequate MTA restoration placed retrogradely considered as Score 5

5) Adequate restoration showing leakage at  $\frac{1}{2}$  up the restoration-root interface or whole leakage at one of the restoration-root interfaces (Figure 6);

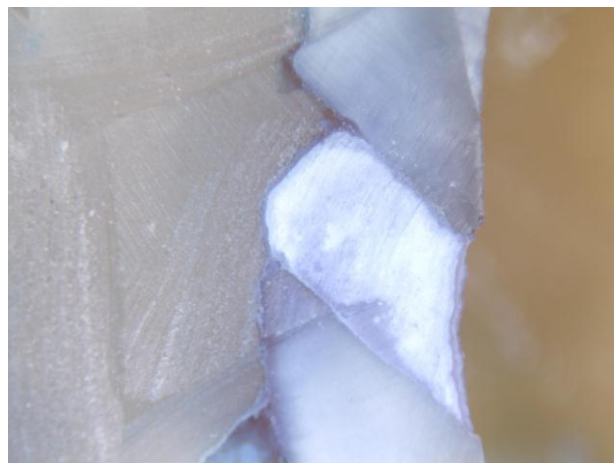
**Figure 7.**

Adequate restoration with IRM placed retrogradely considered as score 6

6) Adequate restoration without leakage (Figure 7).
